NRL/MR/6180--07-9025

Future Naval Concepts — Crew Reductions through Improved Damage Control Communications (FNC-CRIDCC)

Triad Test 2 Report (18-22 Sep 2006)

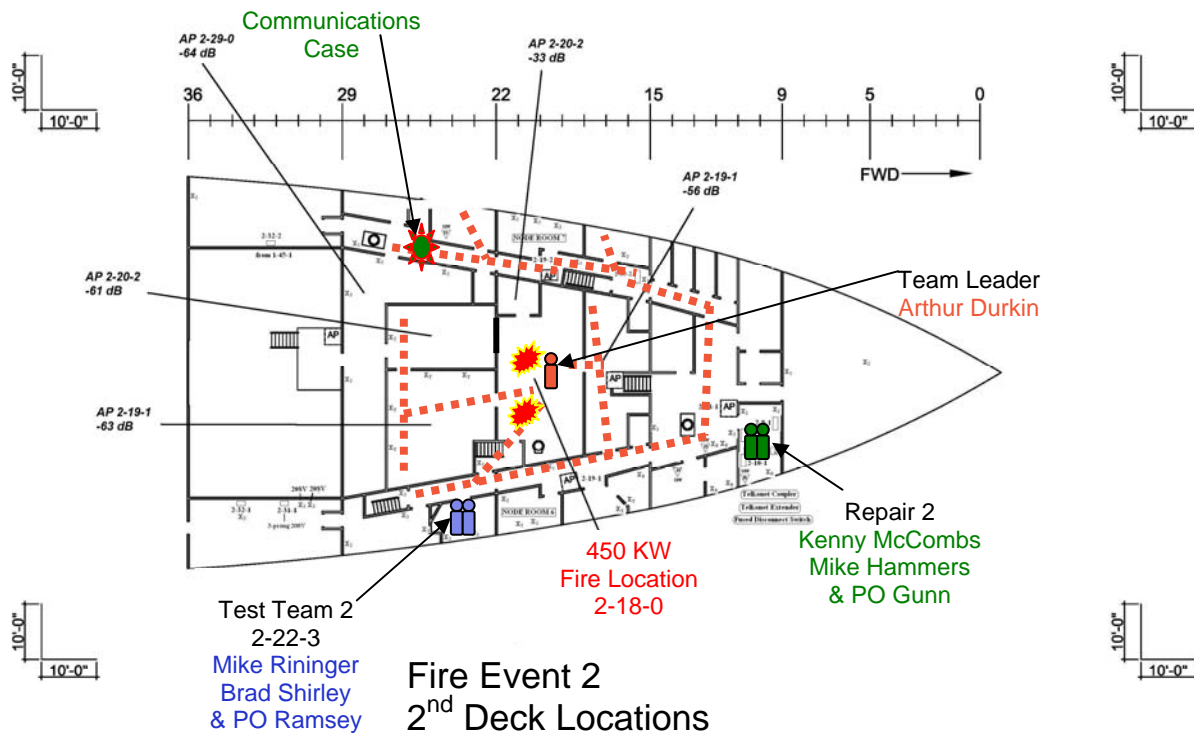
Figure 8 – Location of Fire, Test Team 2 and roaming area for Team leader during Fire Event 2

The Team Leader wore the Triad VoIP Team Leader device (Symbol® MC70 PDA in thermoplastic Pelican 1040 case) on a shoulder strap on the outside of his ensemble. He wore a Philips ear bud with ear hook, and used the Earmark throat microphone. Ship’s force personnel used DCWIFCOM for control and communications. Ship’s Force team leader ignited one 300kW fire and one 150kW fire in compartment 2-18-0 (CIC). The temperature’s high point in CIC was approximately 250° C (482° F).

Figures 6, 7, and 8 illustrate locations of teams and fires for Fire Event 2. The data collection teams used Vocera® communications badges for voice communications and Symbol® MC70 PDAs with iMov® Messenger® client for text messaging/chat to conduct “back channel” communications.

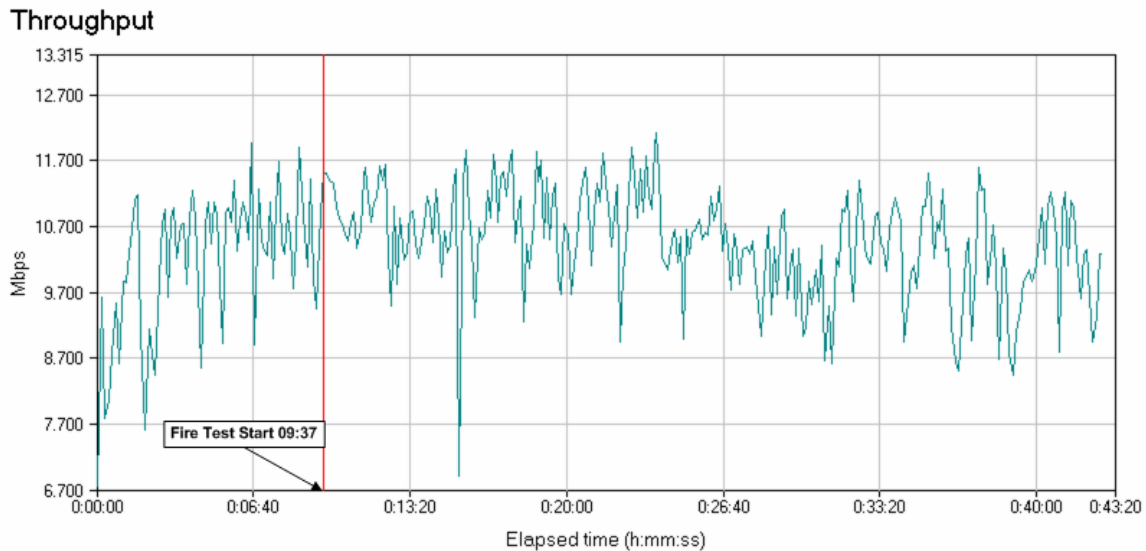
**Figure 10 – Fire Event 2 Throughput Graph**

The graph in Figure 10 illustrates the throughput data collected from the start of the baseline testing to the end of the Fire Event.

Fire Event testing results show that overall throughput decreased slightly during the fire. It is unknown if the cause of this was the fire itself or if it was because of the use of various other networked devices during this time period such as IP cameras, Air Magnet tablet PCs, PDAs, Vocera Badges, Laptop Computers, and smoke modeling sensors.

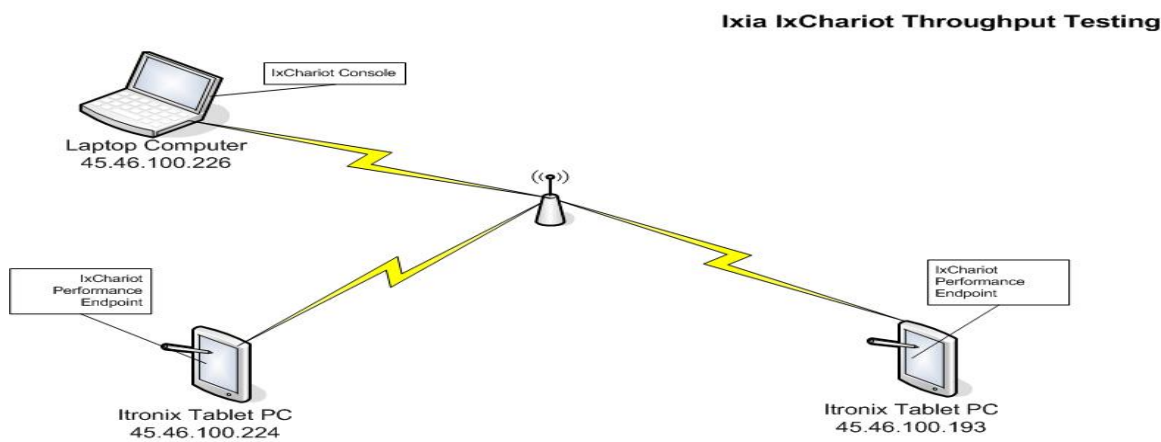
Figure 14 – Fire Event 3 Throughput Testing Topology

Operators changed the performance endpoint configuration during Fire Event 3. They moved one performance endpoint from the passageway outside EDG 1-26-1 to the 02 Level in the passageway near 2-26-1 on the port side of the ship. This endpoint was using the 45.46.100.193 IP address. They moved the other performance endpoint from 2-23-3 to the passageway outside EDG 1-26-1. This endpoint was using the 45.46.100.224 IP address. Figure 14 shows a conceptual depiction of the arrangement.

During this Fire Event, the performance endpoint located in the passageway outside EDG 1-26-1 (45.46.100.224) failed to send data to the IxChariot Console at the end of the testing period. Engineers only collected data from the performance endpoint located in the passageway near 2-26-1 on the port side (45.46.100.193) during this test. There was connectivity between the performance endpoint 45.46.100.224 and the IxChariot console during the entire test, the device itself did not fail.
